Norton Atlas engine overhaul

Part one: stripdown on the Dominator/Atlas/Commando twin cylinder engine with Norton expert Mick Hemmings.

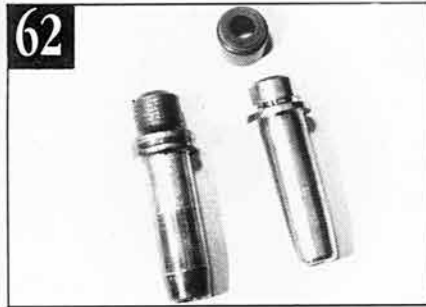
- Mick deemed the valves in this engine to be scrap because they had worn through the hardening on their tips (pic 61).
- Note that Commando inlet valve guides are fitted with rubber stem seals. These are fitted because the engine is inclined forwards. They reduce the amount of oil that can pass along the valve stem and into the combustion chamber. Both types shown in pic 62.
